CRESCENT LAKE DAM

NDI NO. PA-0043

PIKE COUNTY, PENNSYLVANIA

PHASE I INSPECTION REPORT  
NATIONAL DAM INSPECTION PROGRAM

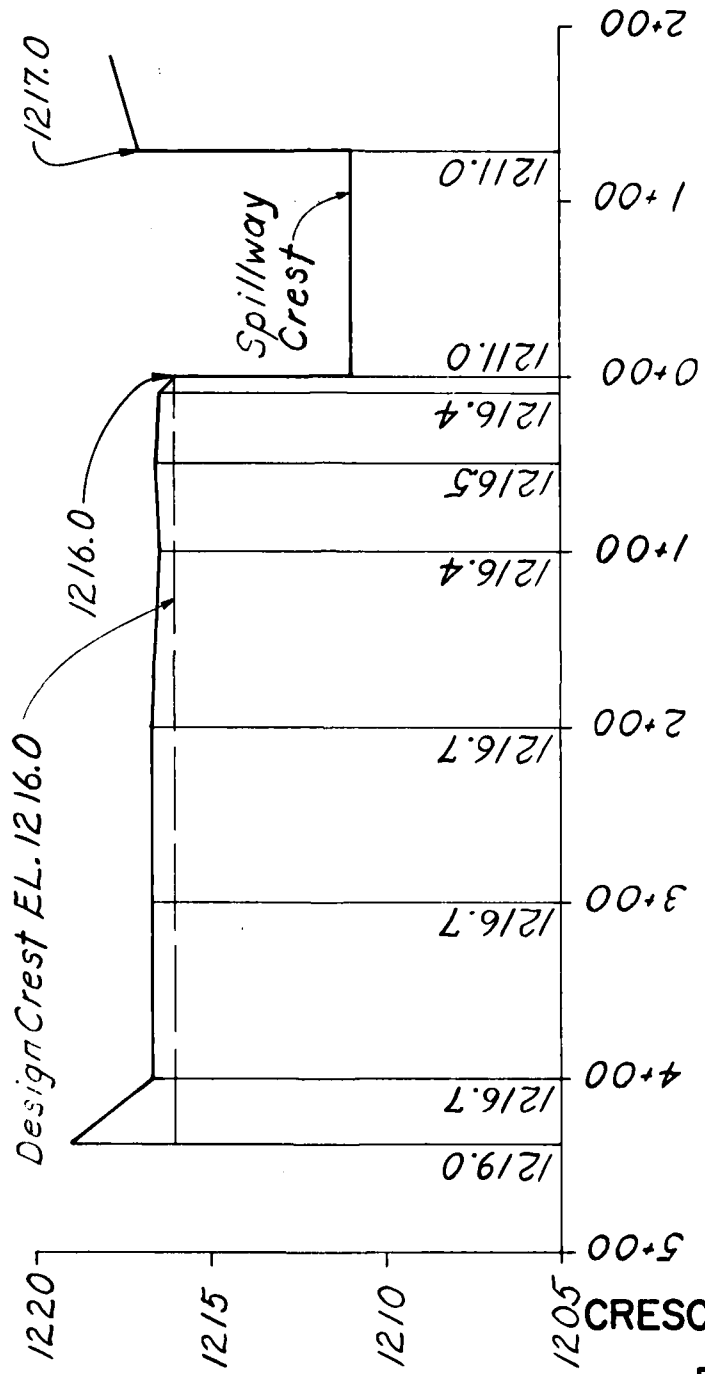
CRESCENT LAKE DAM  
PA.-00413  
INSPECTION SURVEY  
PLATE A-II

D. ALIGNMENT OF CREST: HORIZONTAL: VERTICAL:	Horizontal - Good. Vertical - Refer to Profile, Plate A-II, Appendix A.
E. RIPRAP FAILURES	None evident.
F. JUNCTION EMBANKMENT & ABUTMENT OR SPILLWAY	Abutment at spillway is sound. Abutment at natural ground on left is sound. Concrete wingwall of spillway at right abutment.

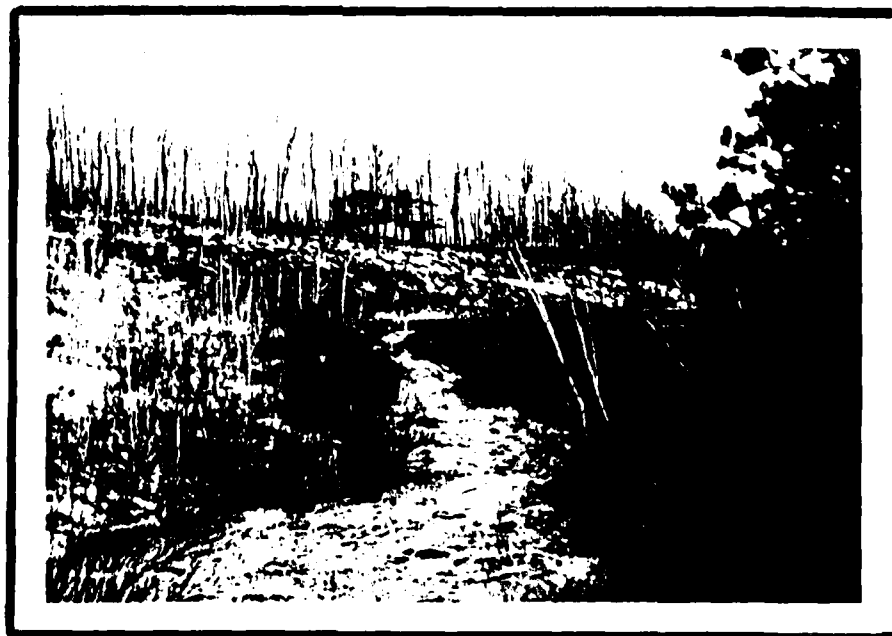
The immediate downstream channel of the spillway is steep with large boulders and steep side slopes. A bridge crosses the channel about 400 feet downstream of the dam. The vertical clearance is more than adequate for the expected runoff. Three homes are located about a quarter-mile downstream of the dam, and a state highway bridge crosses the creek about half a mile downstream of the dam. A potential hazard to loss of life exists downstream if the dam fails. The hazard category is therefore considered to be "High."

DOWNSTREAM CHANNEL LOOKING UPSTREAM FROM BRIDGE - NO. 7
